Upgrading/ Improvement of Roadside Slope/
Retaining Walls on Hong Kong Island (2005-
2008 Programme) – Investigation, Design and
Construction

Heritage Impact Assessment Report for Feature No. 11SW-B/R93 (Sub- division 1), Duddell Street

Report Ref: M45/200

Final | June 2013

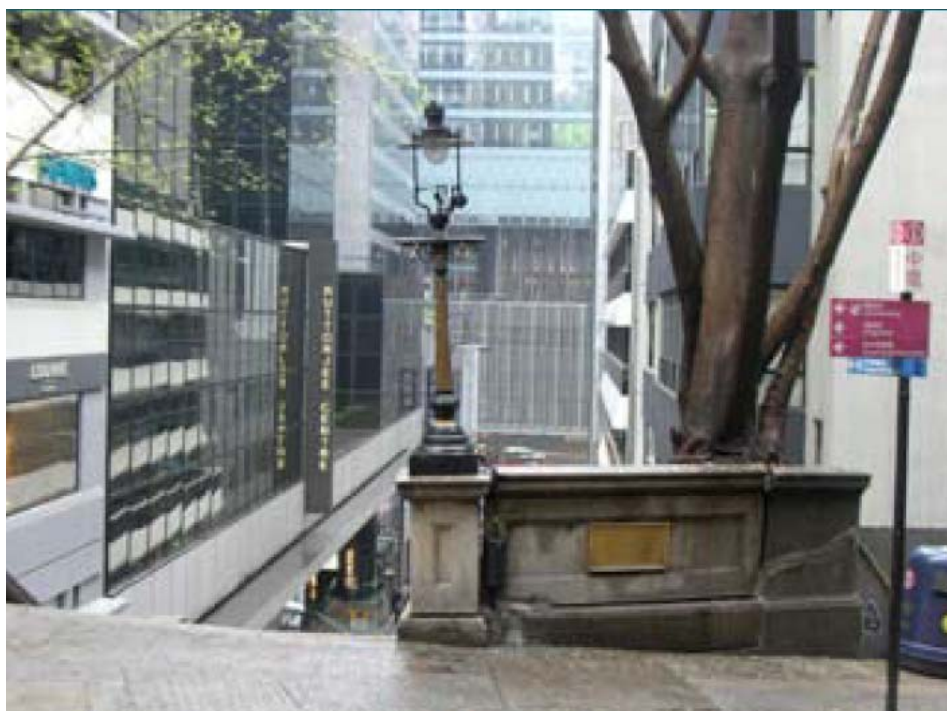
Photo 2.3 – One of the gas lamps was found tilting at Ice House Street

Subsequently, HyD took up the maintenance of the four gas lamps and the stone steps and carry out urgent repair to the tilted gas lamp and the supporting box newel. According to the record, after HyD took up the maintenance responsibilities, the only maintenance works were commenced on July 2009 undertaken by a specialist contractor on the Works Bureau’s approved list of “Repair and Restoration of Historic Building Category” to ensure the quality of works. No other alternation/major repair works were observed which may affect the authenticity of the declared monument throughout the years. Some photos showing the maintenance works are attached below in Photos 2.4 and 2.5. HyD’s Newsletter Issue 3/2009 including the background and procedures of repair works for the declared monuments in 2009 and the Works Order for

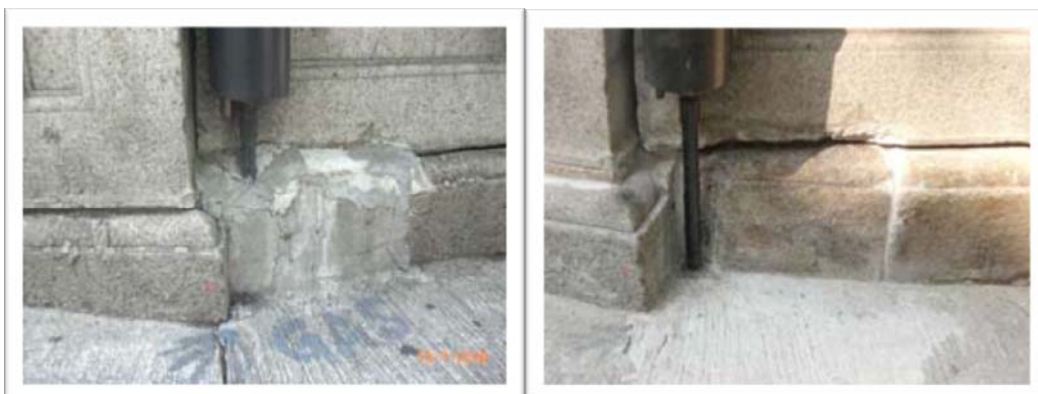
Photo 2.4 – Damaged portion previously patched with cement mortar

Photo 2.5 – Damaged portion after repairing by specialist contractor

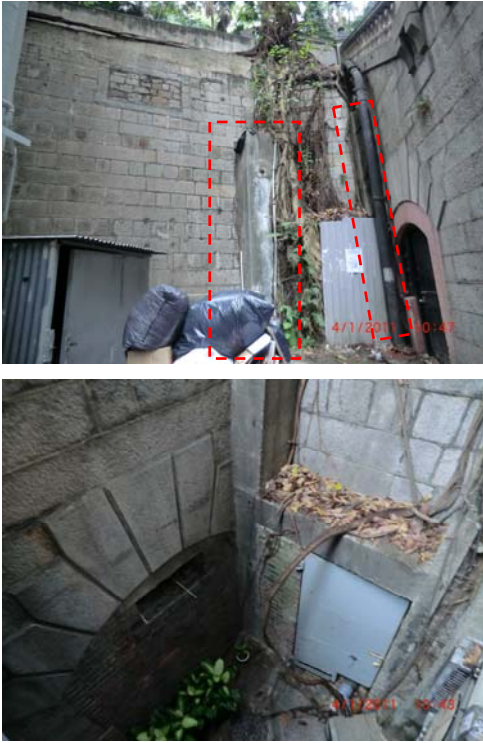
<p>Moderate</p>
<p>Counterforts were observed on the surface of Feature No. 11SW-B/R93 above both portals.</p>		
<p>The masonry sidewalls and rows of flat precast reinforced concrete lintels at the ceilings of tunnels behind Portals 43 and 44 (refers to Section 2.2.2)</p>

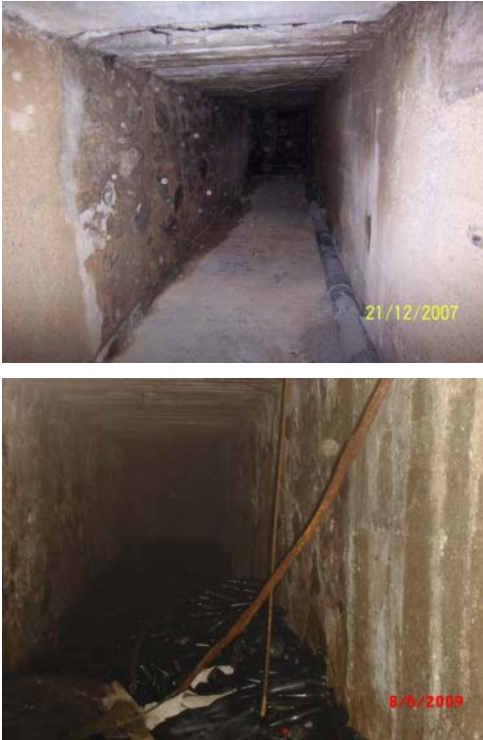
<p>Moderate</p>
<p>At the end of both existing disused tunnels are backfilled by large amount of boulders and cement.</p>

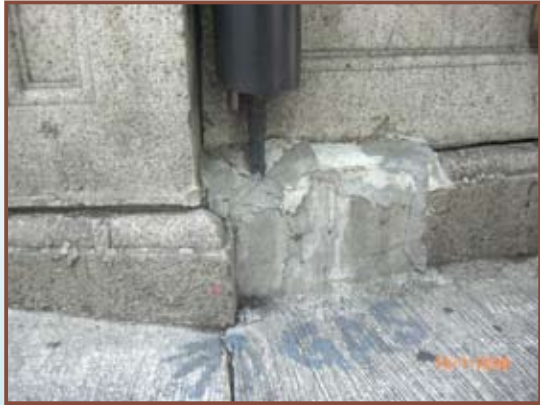
During the restoration of the broken portion at the footing of the granite parapet adjacent to the gas lamp at the upper end of the Stone Steps, previous patches by cement mortar were removed and a granite stone cut to the size and shape of the broken portion was fixed to the cavity. The gap around the granite stone was filled with lime mortar and the granite stone was treated to match in color with the adjacent existing footing.

Damaged portion previously patched with cement mortar

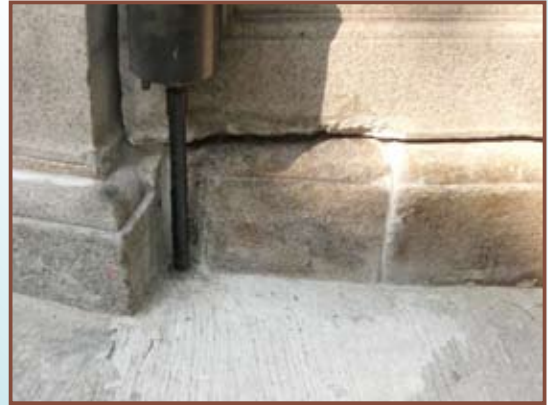
Damaged portion after repairing by specialist contractor

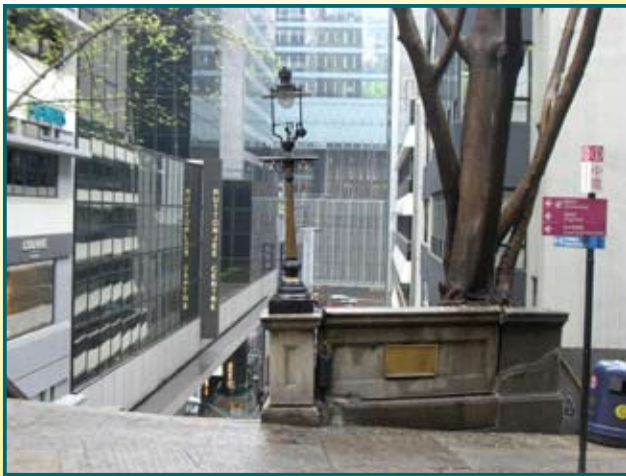
The gas lamp together with the stone column were tilted due to the intrusion of tree roots growing from an adjacent wall tree into the joints of the gas lamp and stone column.

Tilted gas lamp and stone column at upper end of the Stone Steps

- The gas lamp and stone column were lifted up in two operations.
- The roots inside the stone column foundation were cleared under the direction of HyD's Landscape Architect.
- The stone column was re-fixed with lime mortar laid on the foundation.
- The gas lamp was set on the stone column with lime mortar and adjusted to vertical.

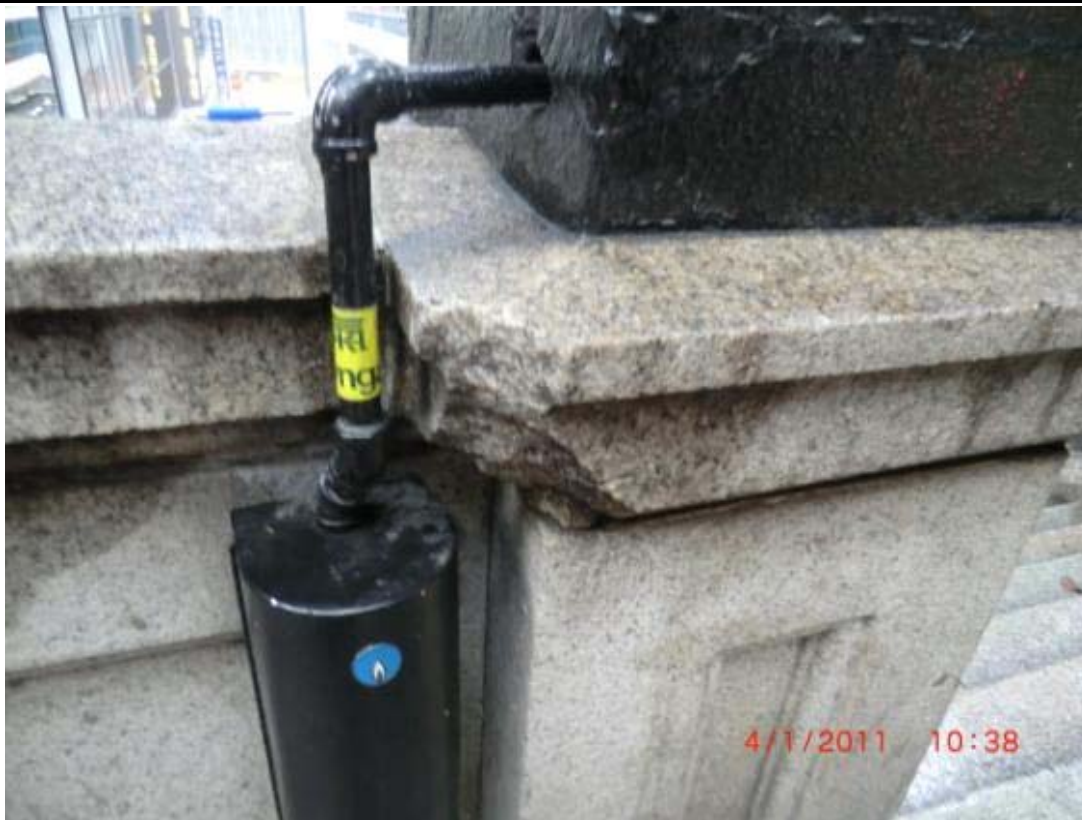
Subject	Parapet wall at north-western side (Plate 5)	Date photograph taken	04-Jan-11
----------------	--	------------------------------	-----------

Description	Part of the corner at the box newel supporting the gas lamp is broken
--------------------	---

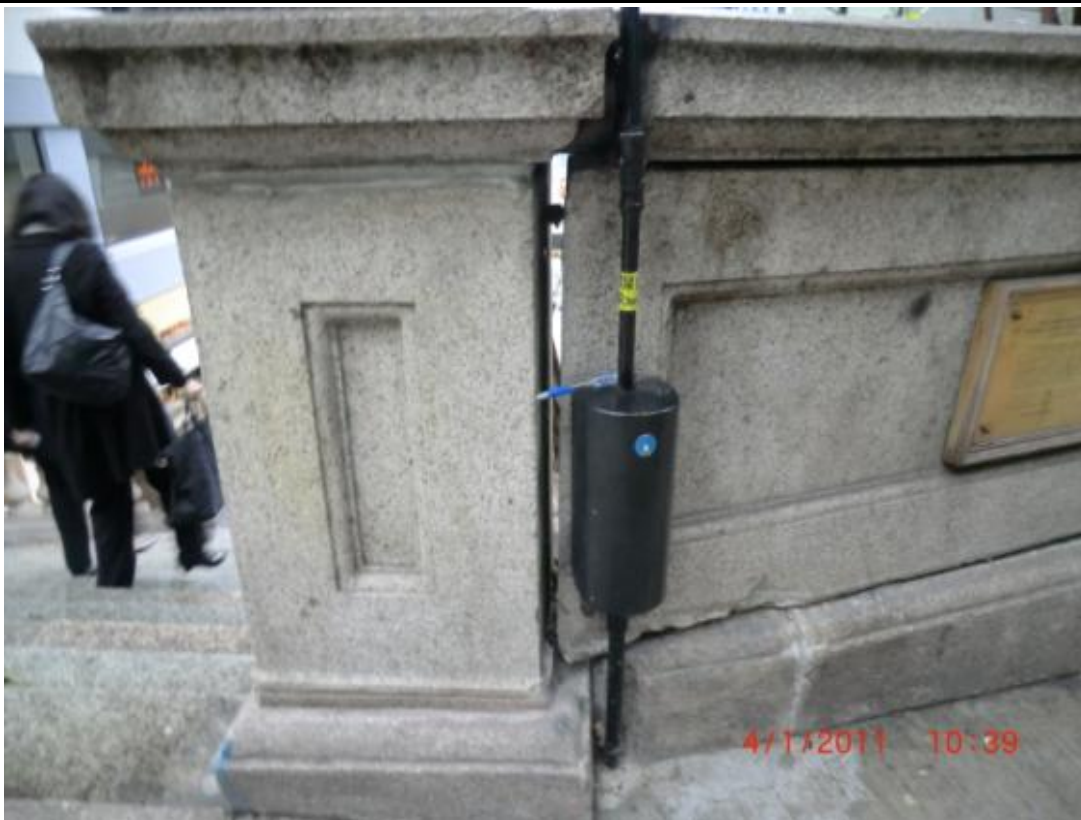
Subject Parapet wall at south-western side (Plate 8) **Date photograph taken** 04-Jan-11

box newel are observed during the inspection. The gaps are anticipated to be formed due to the extension of tree roots from an existing wall tree growing above the Feature adjacent to the parapet wall.

Description A gap between the box newel and the south-western side of the parapet wall is observed

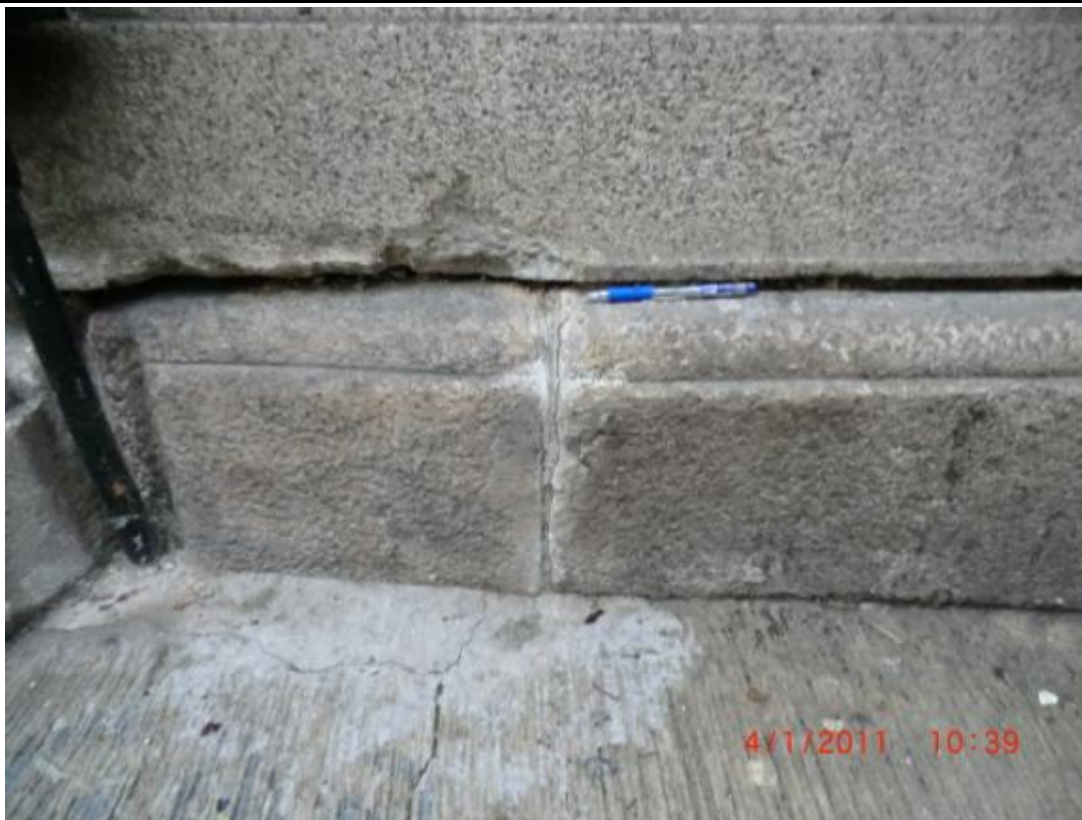
Subject Parapet wall at south-western side (Plate 10) **Date photograph taken** 04-Jan-11

Description One of the box newels at the south-western of the feature is damaged by the tree roots

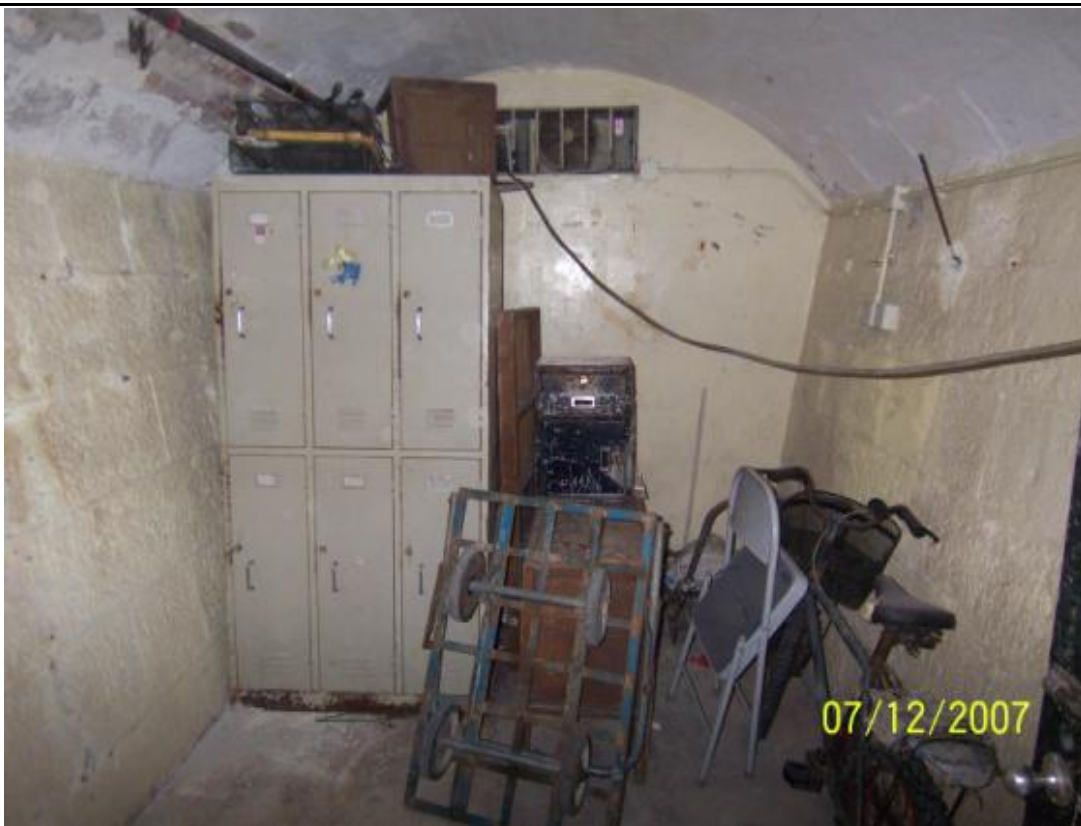
Subject Storeroom with arch ceiling (Plate 38) **Date photograph taken** 07-Dec-07

Description The condition of the wooden door and glass window is considered fair

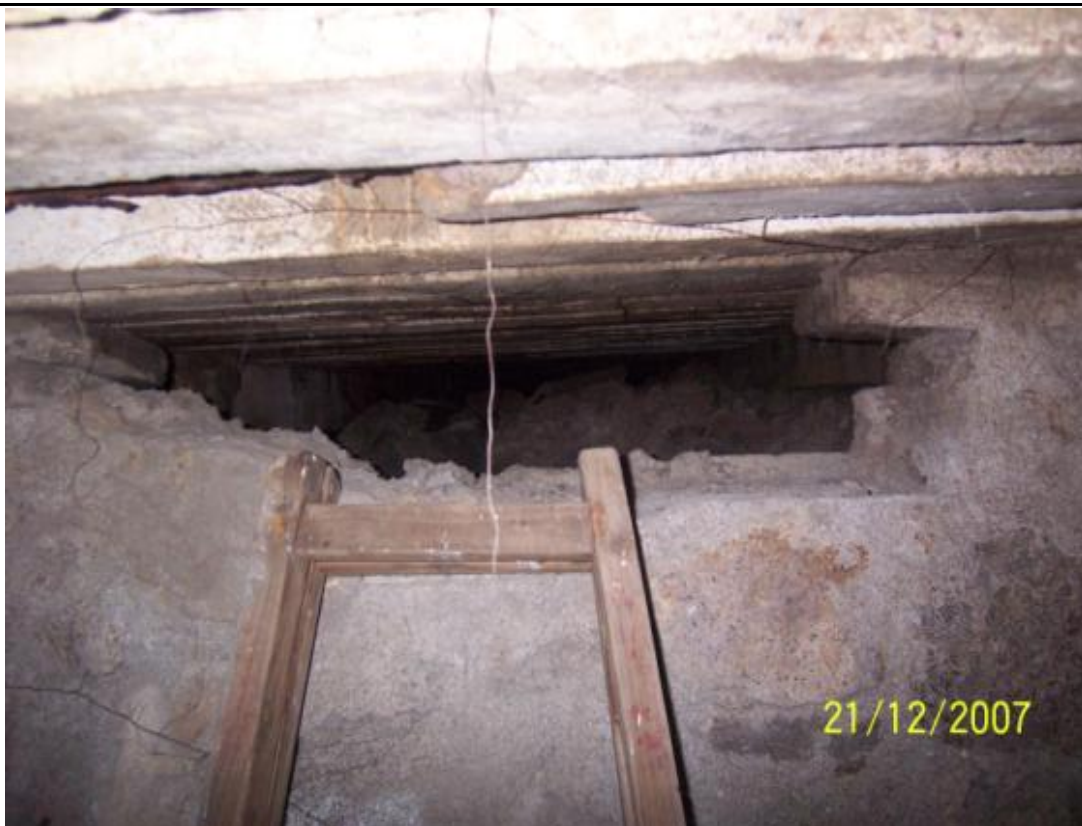
Subject Disused tunnel connected to Portal 43 (Plate 48) **Date photograph taken** 21-Dec-07

Description Row of flat precast reinforced concrete lintels is observed at the ceiling
